Air Accidents Investigation Branch

**Report on the accident to
Antonov AN 28, HA-LAJ
at RAF Weston-on-the-Green, Oxfordshire
on 28 August 1993**

Aircraft Accident Report No: 4/95

(EW/C93/8/5)

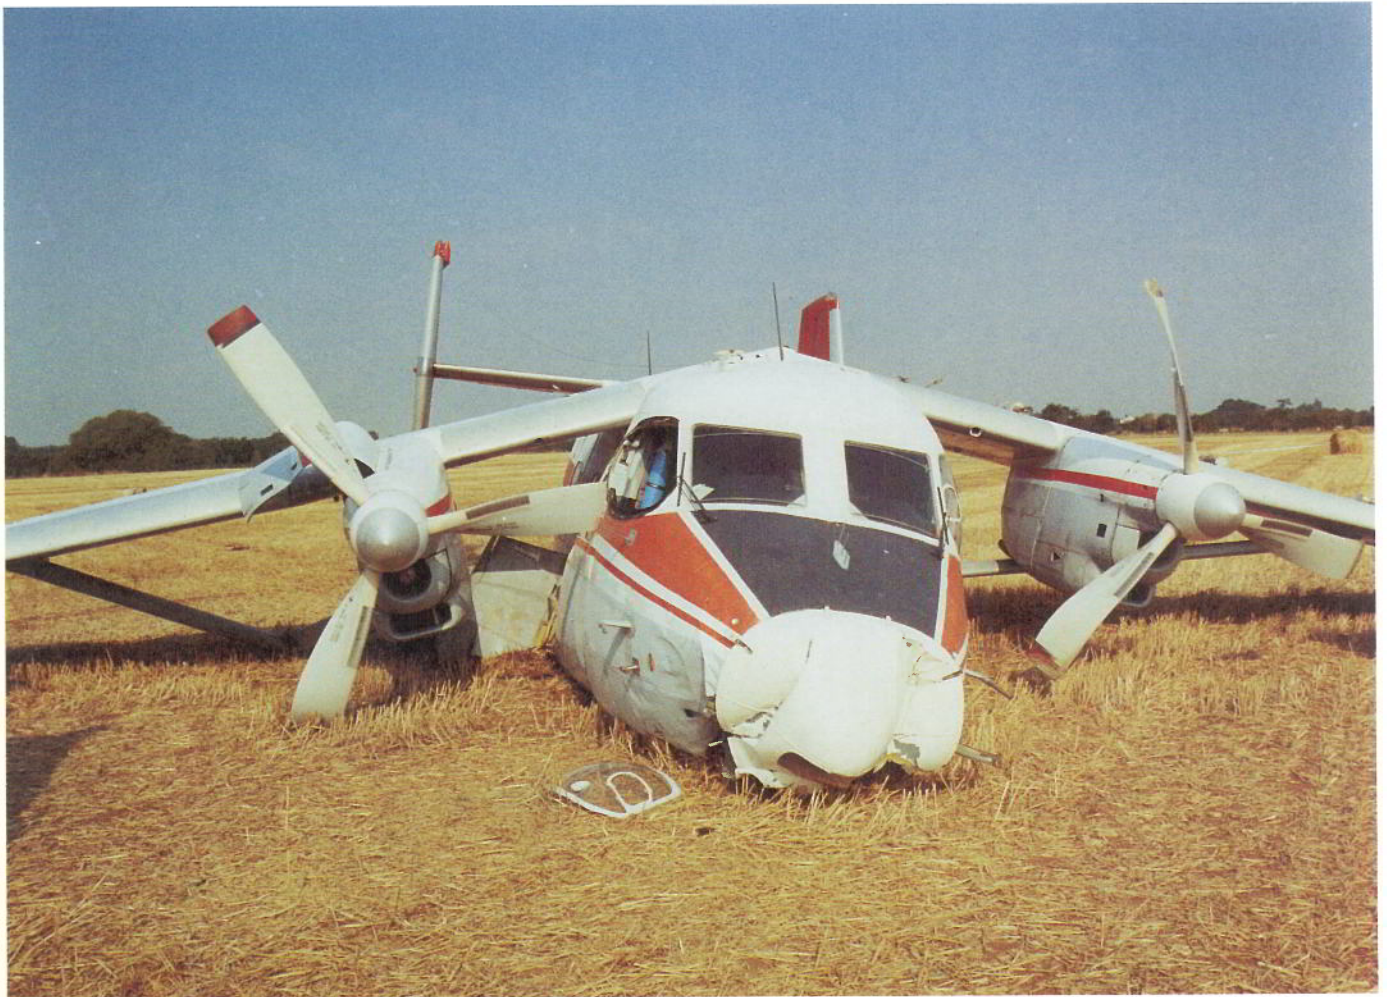
Showing damaged aircraft on site after forced landing

The aircraft was found to have struck the ground in a nose up, slightly right-wing low attitude with a high rate of descent and sufficient forward speed to achieve a ground slide of some 120 metres. All three landing gear units appeared to have collapsed on initial ground contact. Structural failure within the sponsons caused disruption of the struts supporting the outer wings and consequent gradually increasing anhedral of the wing structure as the aircraft slowed during the ground slide. This resulted in both wingtips and both aileron mass balance weights contacting the ground. The latter contact caused the outboard sections of both of the fabric covered ailerons to be torn off.

Although the damage was such that the underside of the fuselage was disrupted (particularly in the region of the main landing gear sponsons) and the cross-sectional shape of the fuselage was considerably altered, the floor remained almost intact and no significant penetration of the cabin occurred.

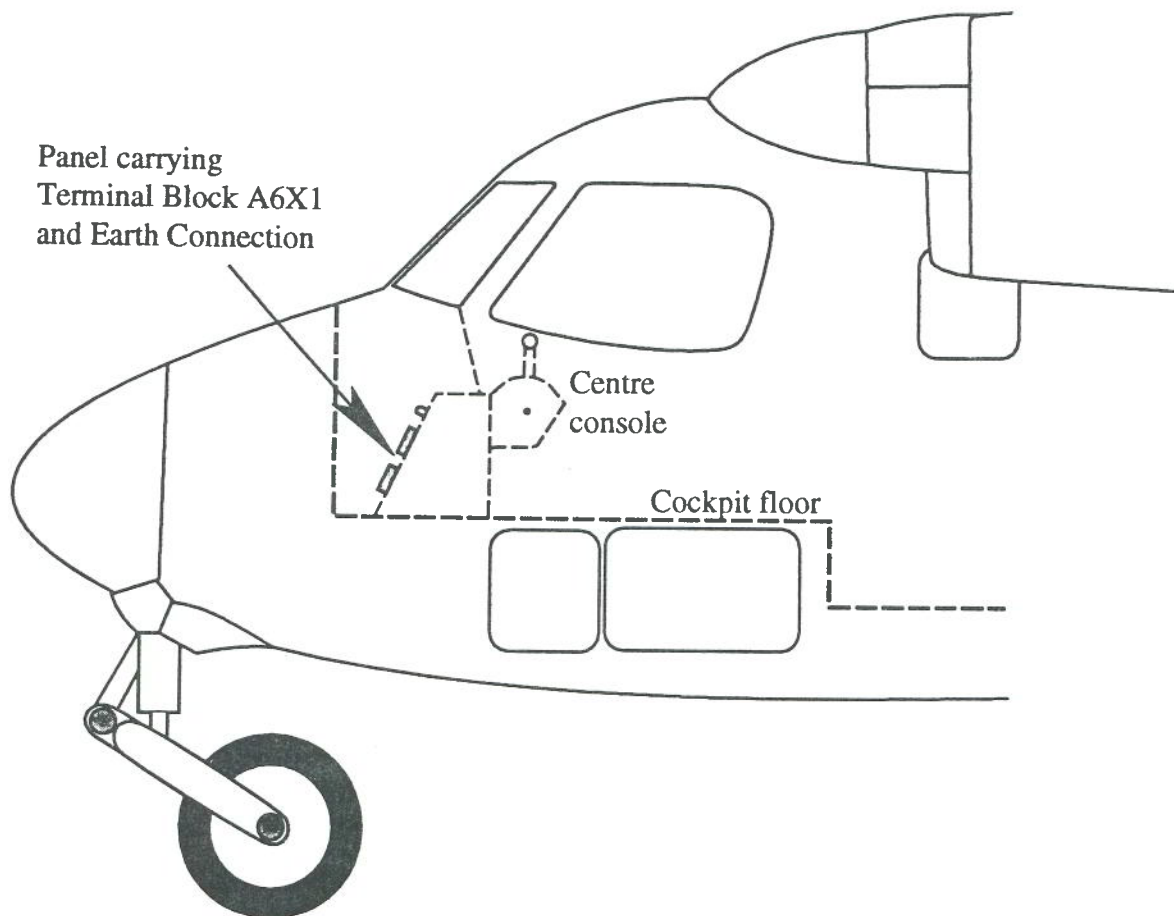
Electrical checks were carried out in the console area with the assistance of the representatives of the Russian Department of Air Transport, after the wreckage had been recovered to Farnborough. It was found that a resistance of over 100 ohms existed between earth and connections of the terminal block A6X1 of the flap signalling system and the autofeather/fuel shut-off/asymmetric spoiler system. This resistance should have been of the order of 1 ohm if the terminal block A6X1 was correctly earthed.

Figure1 Diagram showing location of terminal block A6X1 and associated earth connection on forward face of centre console in cockpit

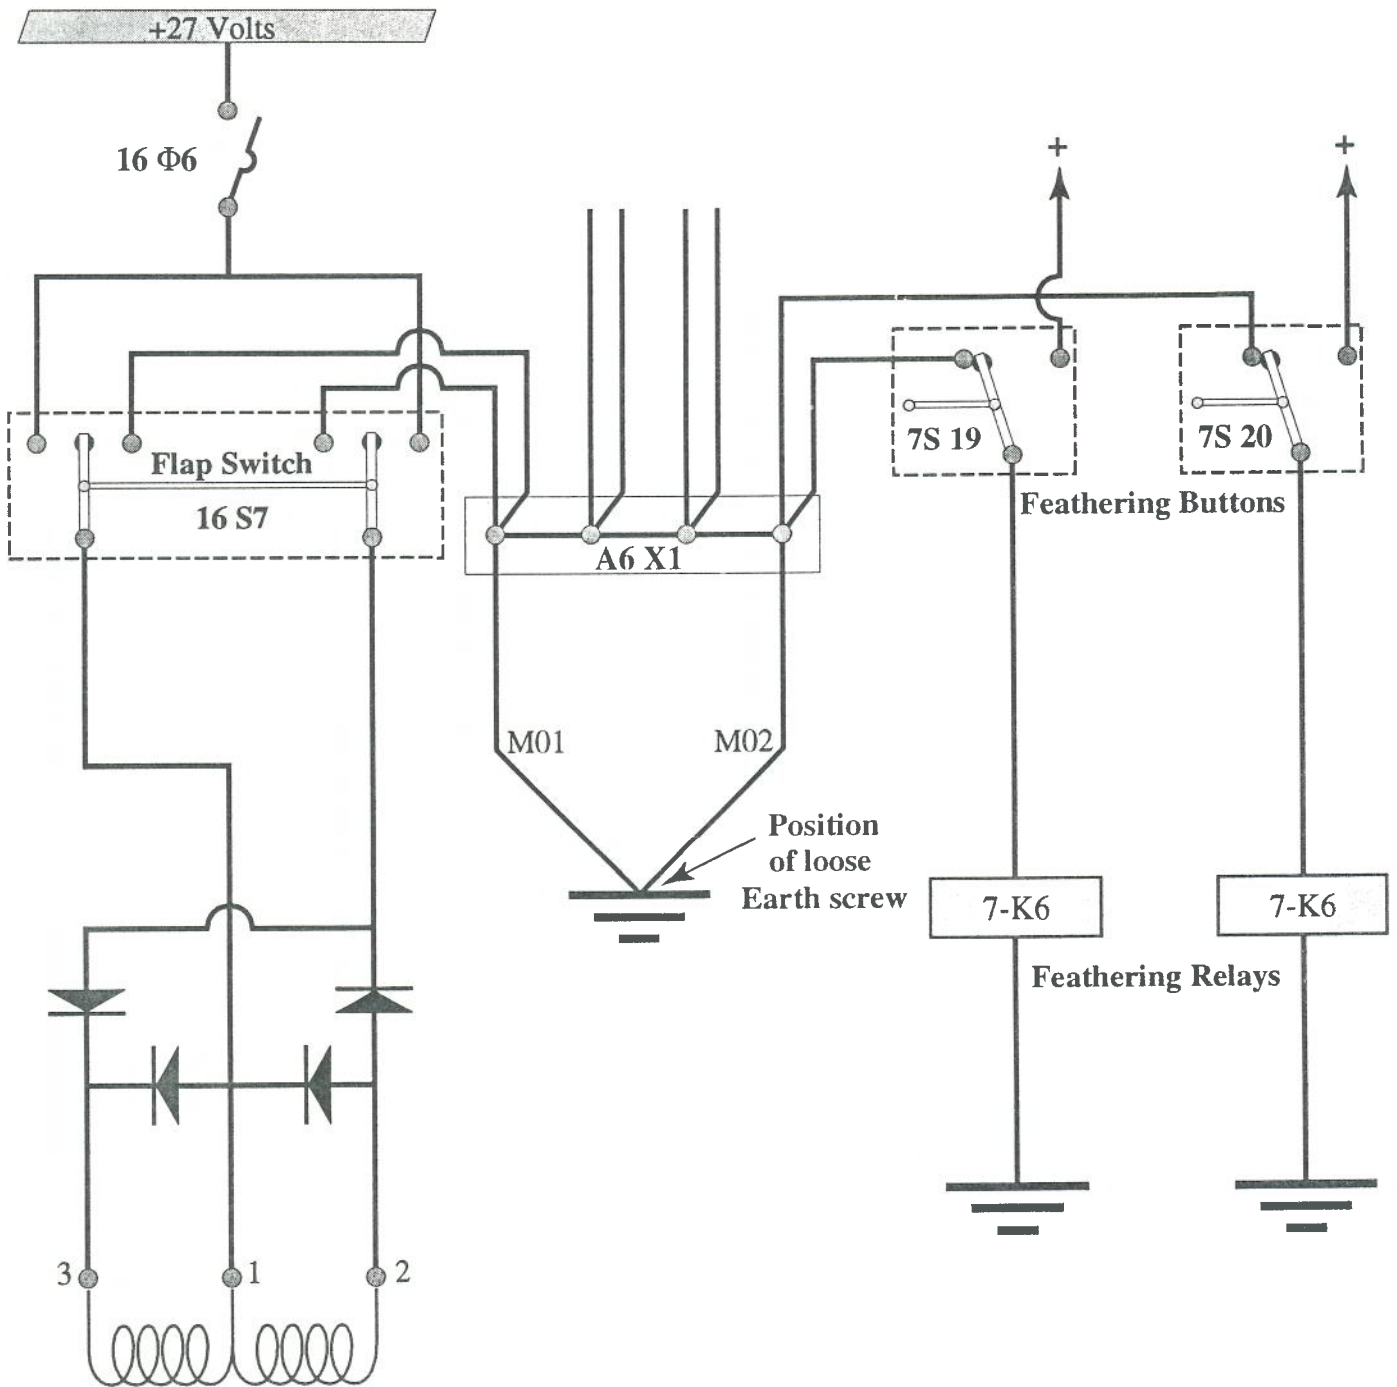
Figure 2

The original design of the wiring, incorporating two earth cables MO1 and MO2, appears to have been carried out with the intention of ensuring an element of redundancy, to safeguard against a loss of continuity between earth and those circuits arriving at terminal block A6X1. At some stage between the original evolution of the wiring system design and the production of detail manufacturing drawings, however, the earth redundancy of the design was lost and a single point failure mode became possible.

In practice, combining the earthing of a number of circuits on a single terminal block, which was then separately earthed, was not a sound design philosophy. Even had two separate earth lead attachment screws been used, no means of detecting loss of continuity via one screw would have been readily available, leaving a dormant failure possible.

Showing schematic diagram of wiring connections between the flap selection and propeller feathering systems and the terminal block A6 X1 combined earthing point.

Widely used design principles for identifying common-mode failures, if applied at the stage when manufacturing drawings were available, should have revealed the potential hazard of any common earth arrangement in this area. Automatic safety systems such as the autofeathering/engine shutdown arrangements on the AN 28 demand a high level of integrity. This, in practice, requires individual earthing of each system and/or provision of effective reverse current protection.

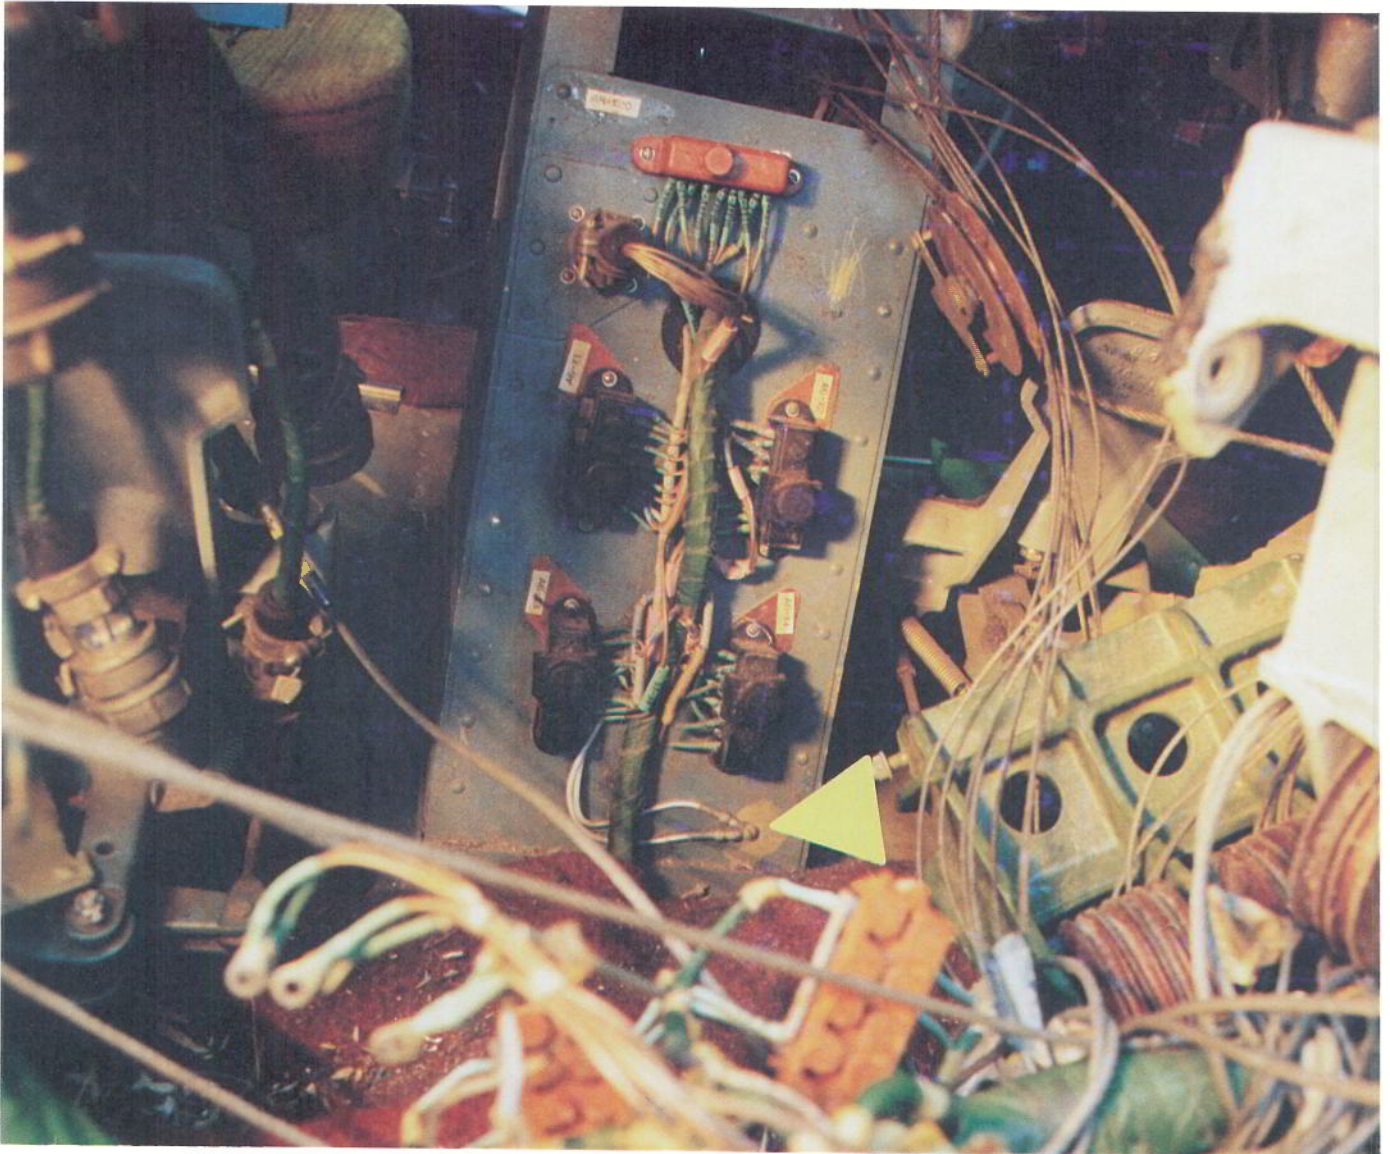
Further examination showed that the immediate cause of this high resistance was the fact that the screw securing the two earthing tags of the terminal block A6X1 was loose. This was clearly not an effect of the ground impact.

Examination of the relevant area of the wreckage, after the results of the above trial were described, confirmed that the screw attaching the two earth leads to the terminal-block mounting panel was loose (see section 1.12.2). Electrical tests confirmed that this resulted in a very high resistance between the terminal block A6X1 and earth. Looseness of the screw was clearly not an impact feature.

This looseness created electrical conditions which were exactly as simulated by the conditions of the reported trial. The increased resistance of the normal earth path from terminal-block A6X1, (approximately 100 ohms as opposed to a normal figure of approximately 1 ohm) arising from the loose screw, was greater than the minimum possible resistance to earth via the autofeather system relays. (The exact resistance of this path depends on the position of switching in the autofeather circuits). Hence the earth current took the lowest resistance path available, in the absence of a direct earth connection, energising both autofeathering relays as it did so, leading to feathering of both propellers and operation of the emergency automatic shutdown systems on both sides of the aircraft.

Although the earthing screw was loose at the time it was examined, it is reasonable to suppose that progressive slackness had developed over a period and that the resistance between the cable ends (MO1 and MO2) and earth would have varied with conditions of acceleration and vibration. The slackness may therefore have been present for a period before the critically high resistance between the terminal ends and earth occurred co-incident with flap retraction.

Figure 3 Showing terminal block A6X1 with loose earthing screw arrowed
